# Allied-Axis

THE PHOTO JOURNAL OF THE SECOND WORLD WAR

# Contents

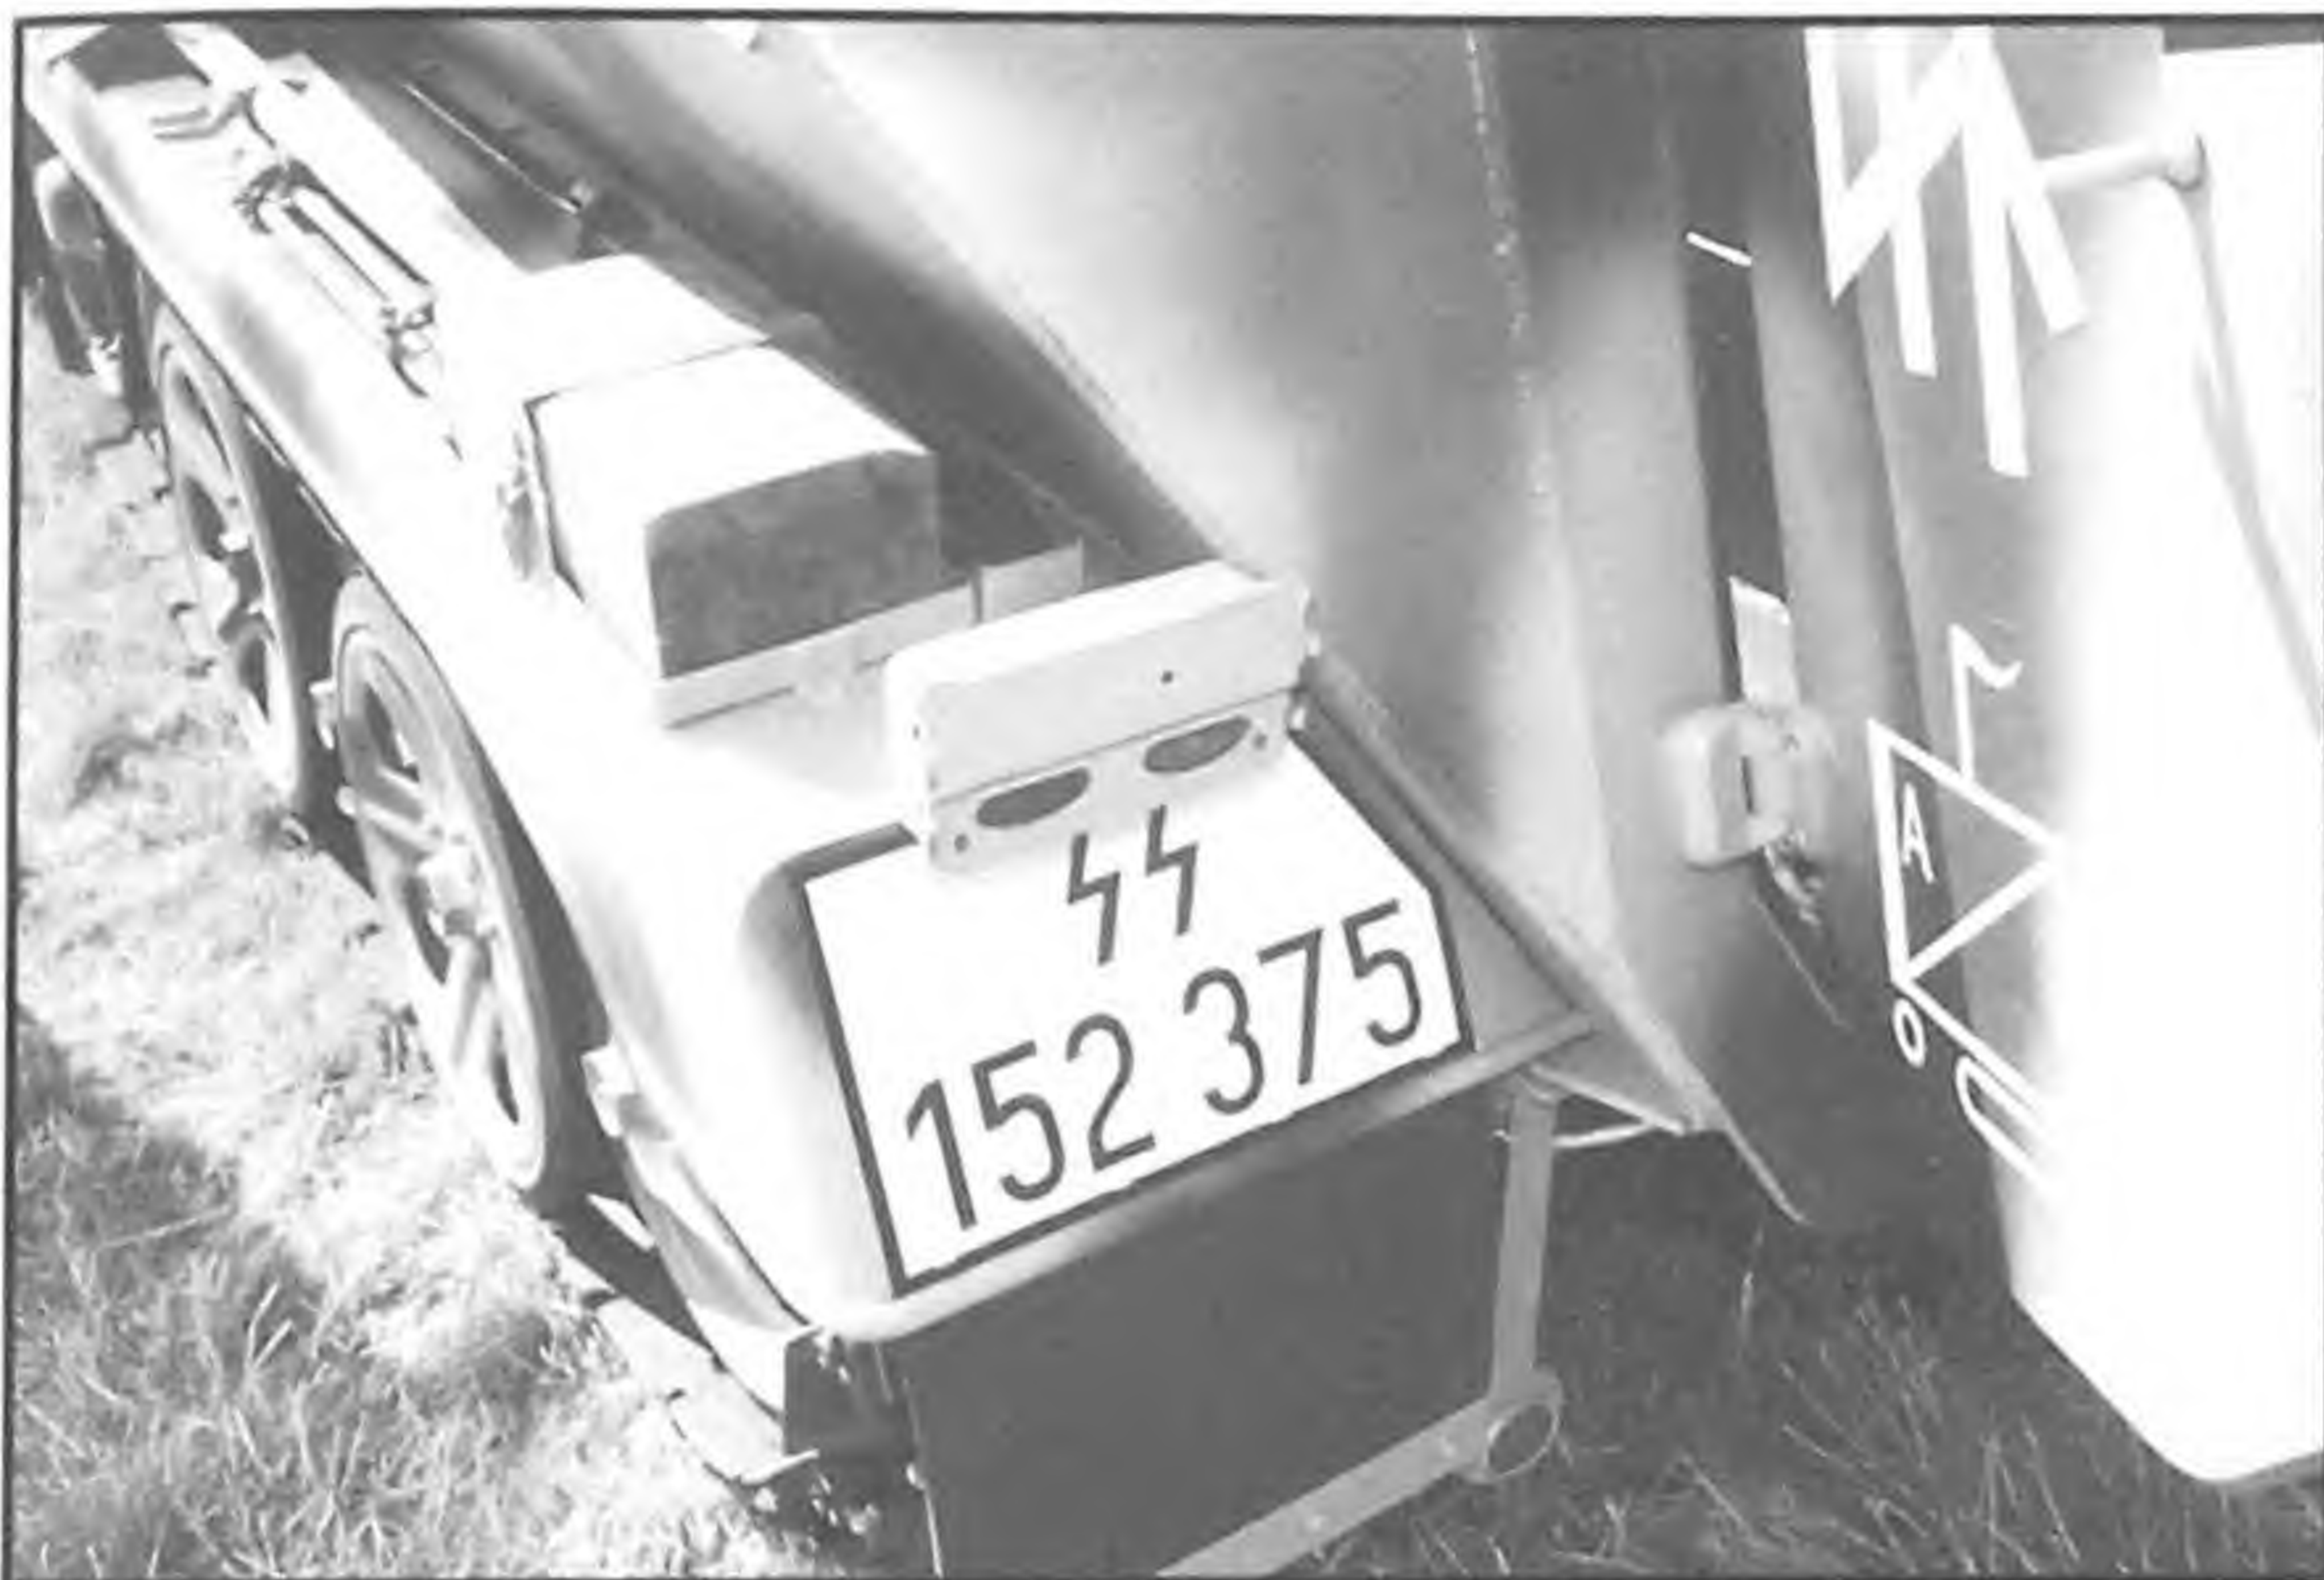
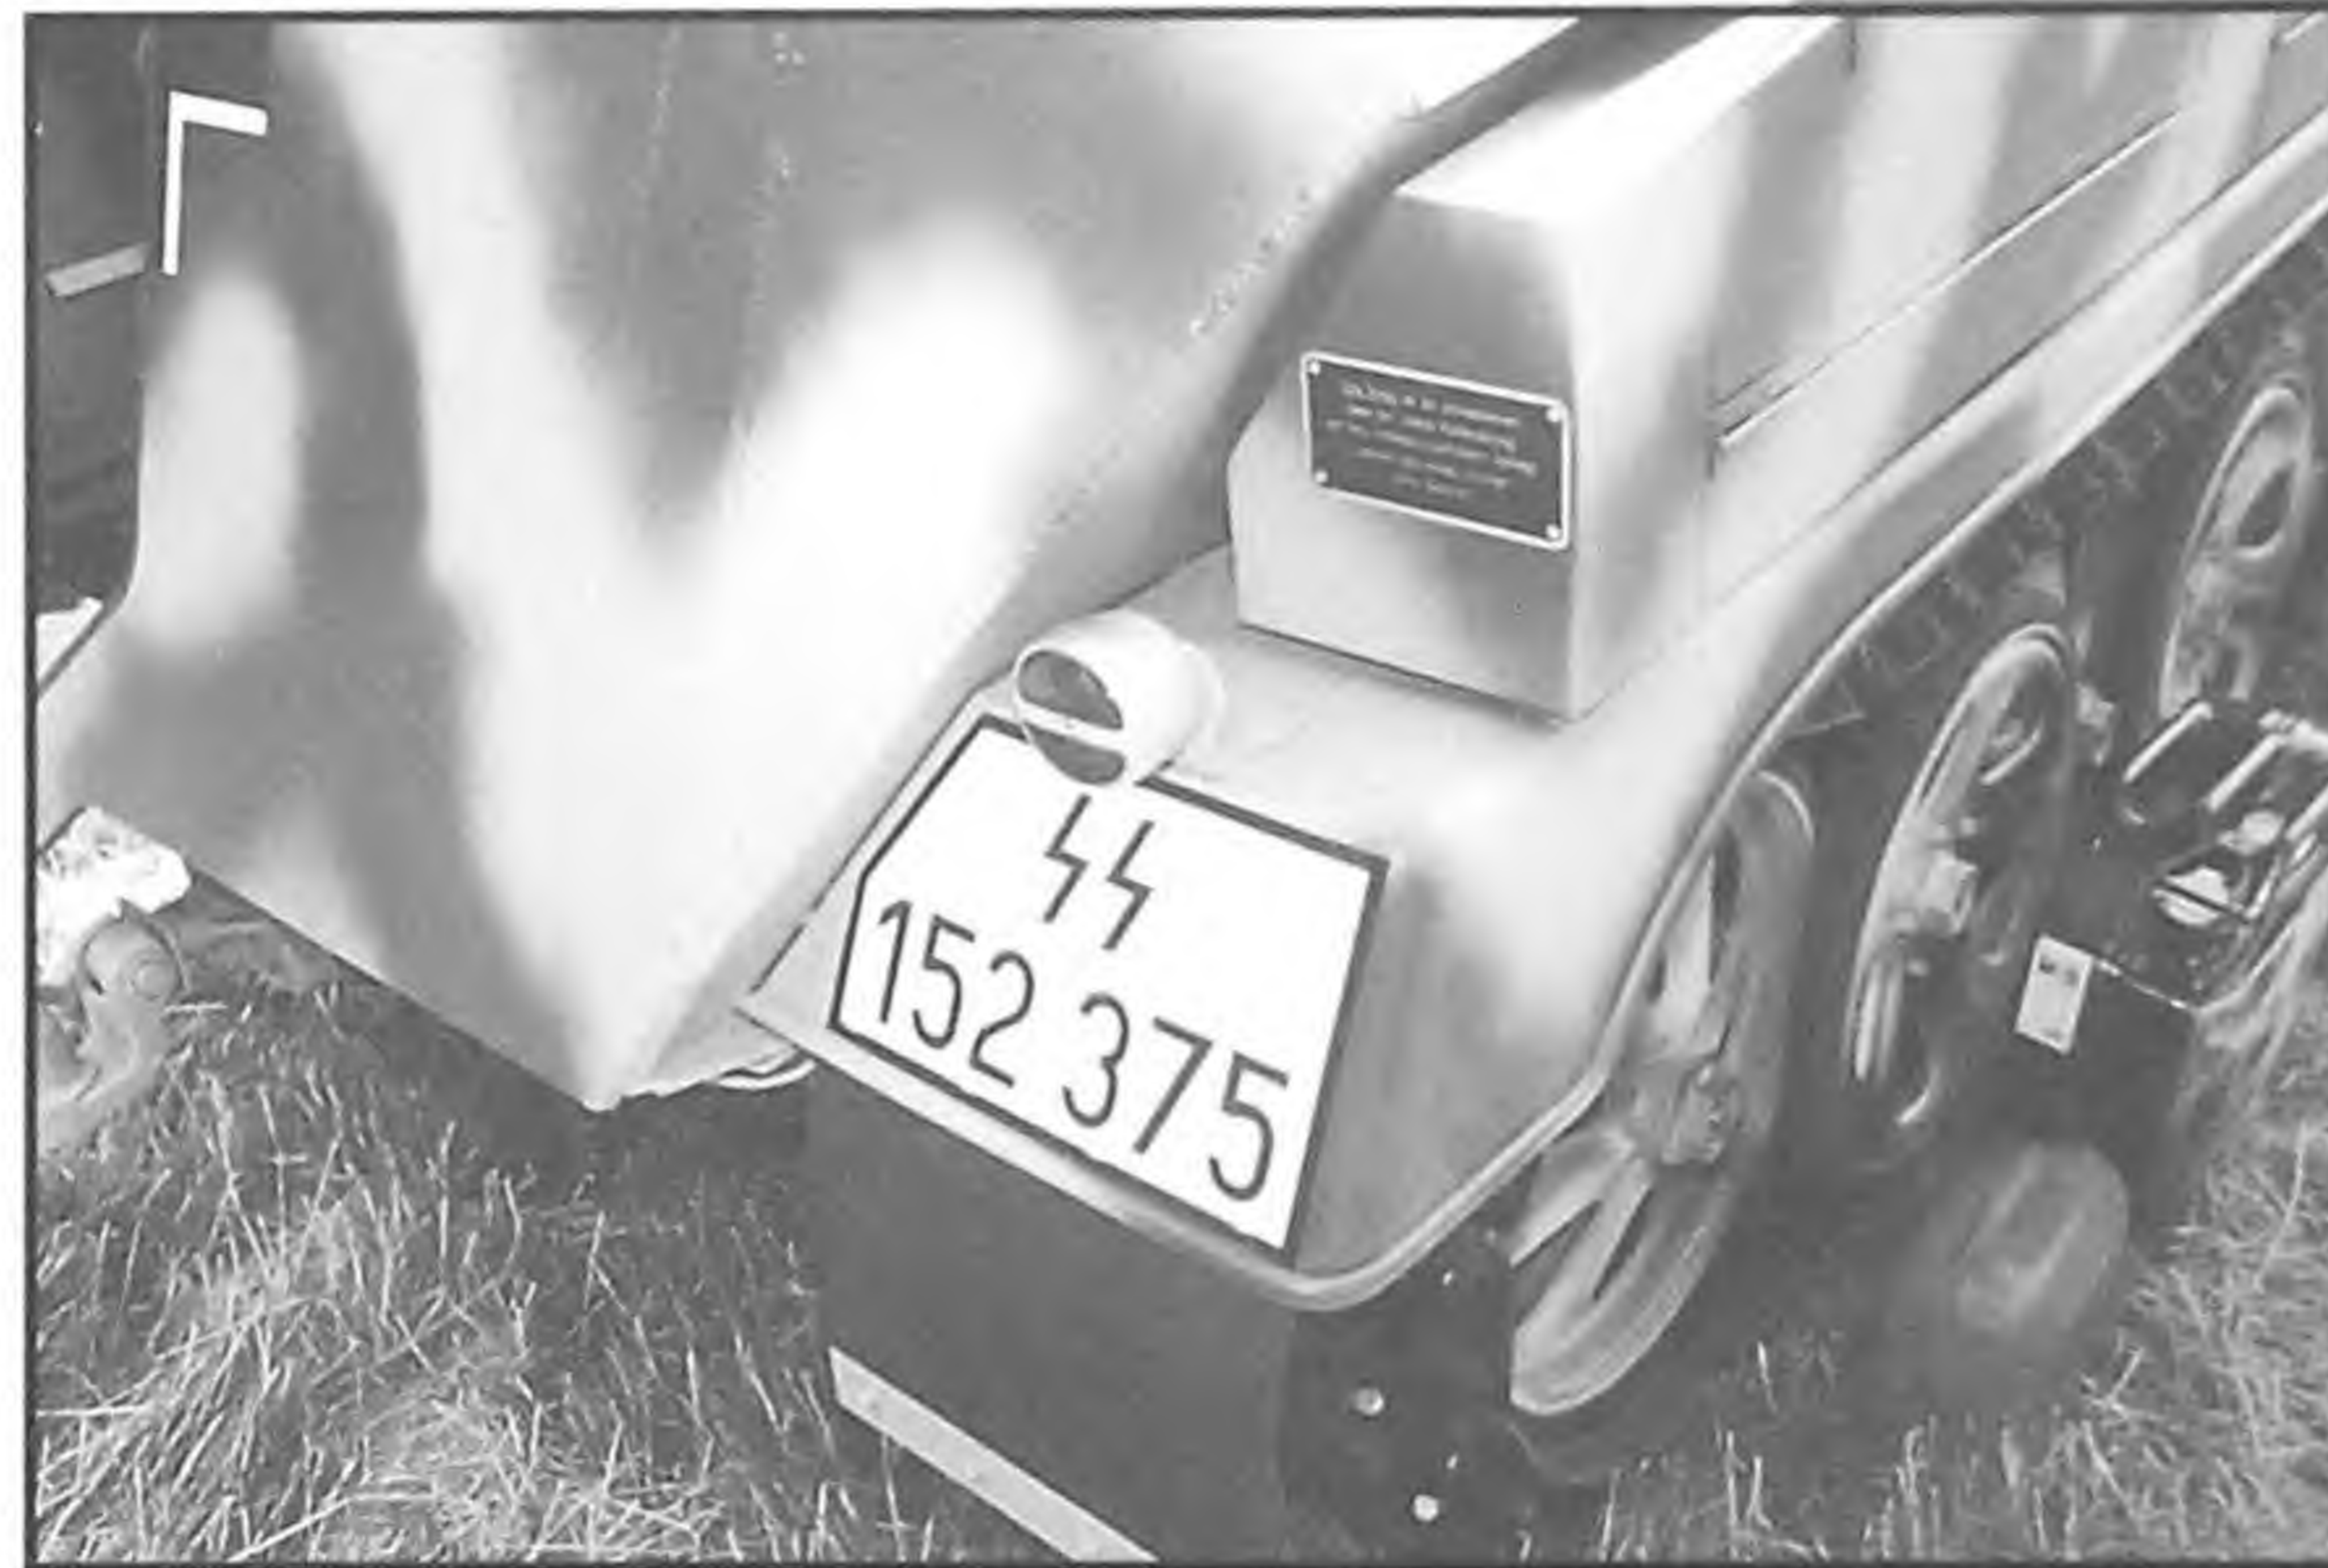
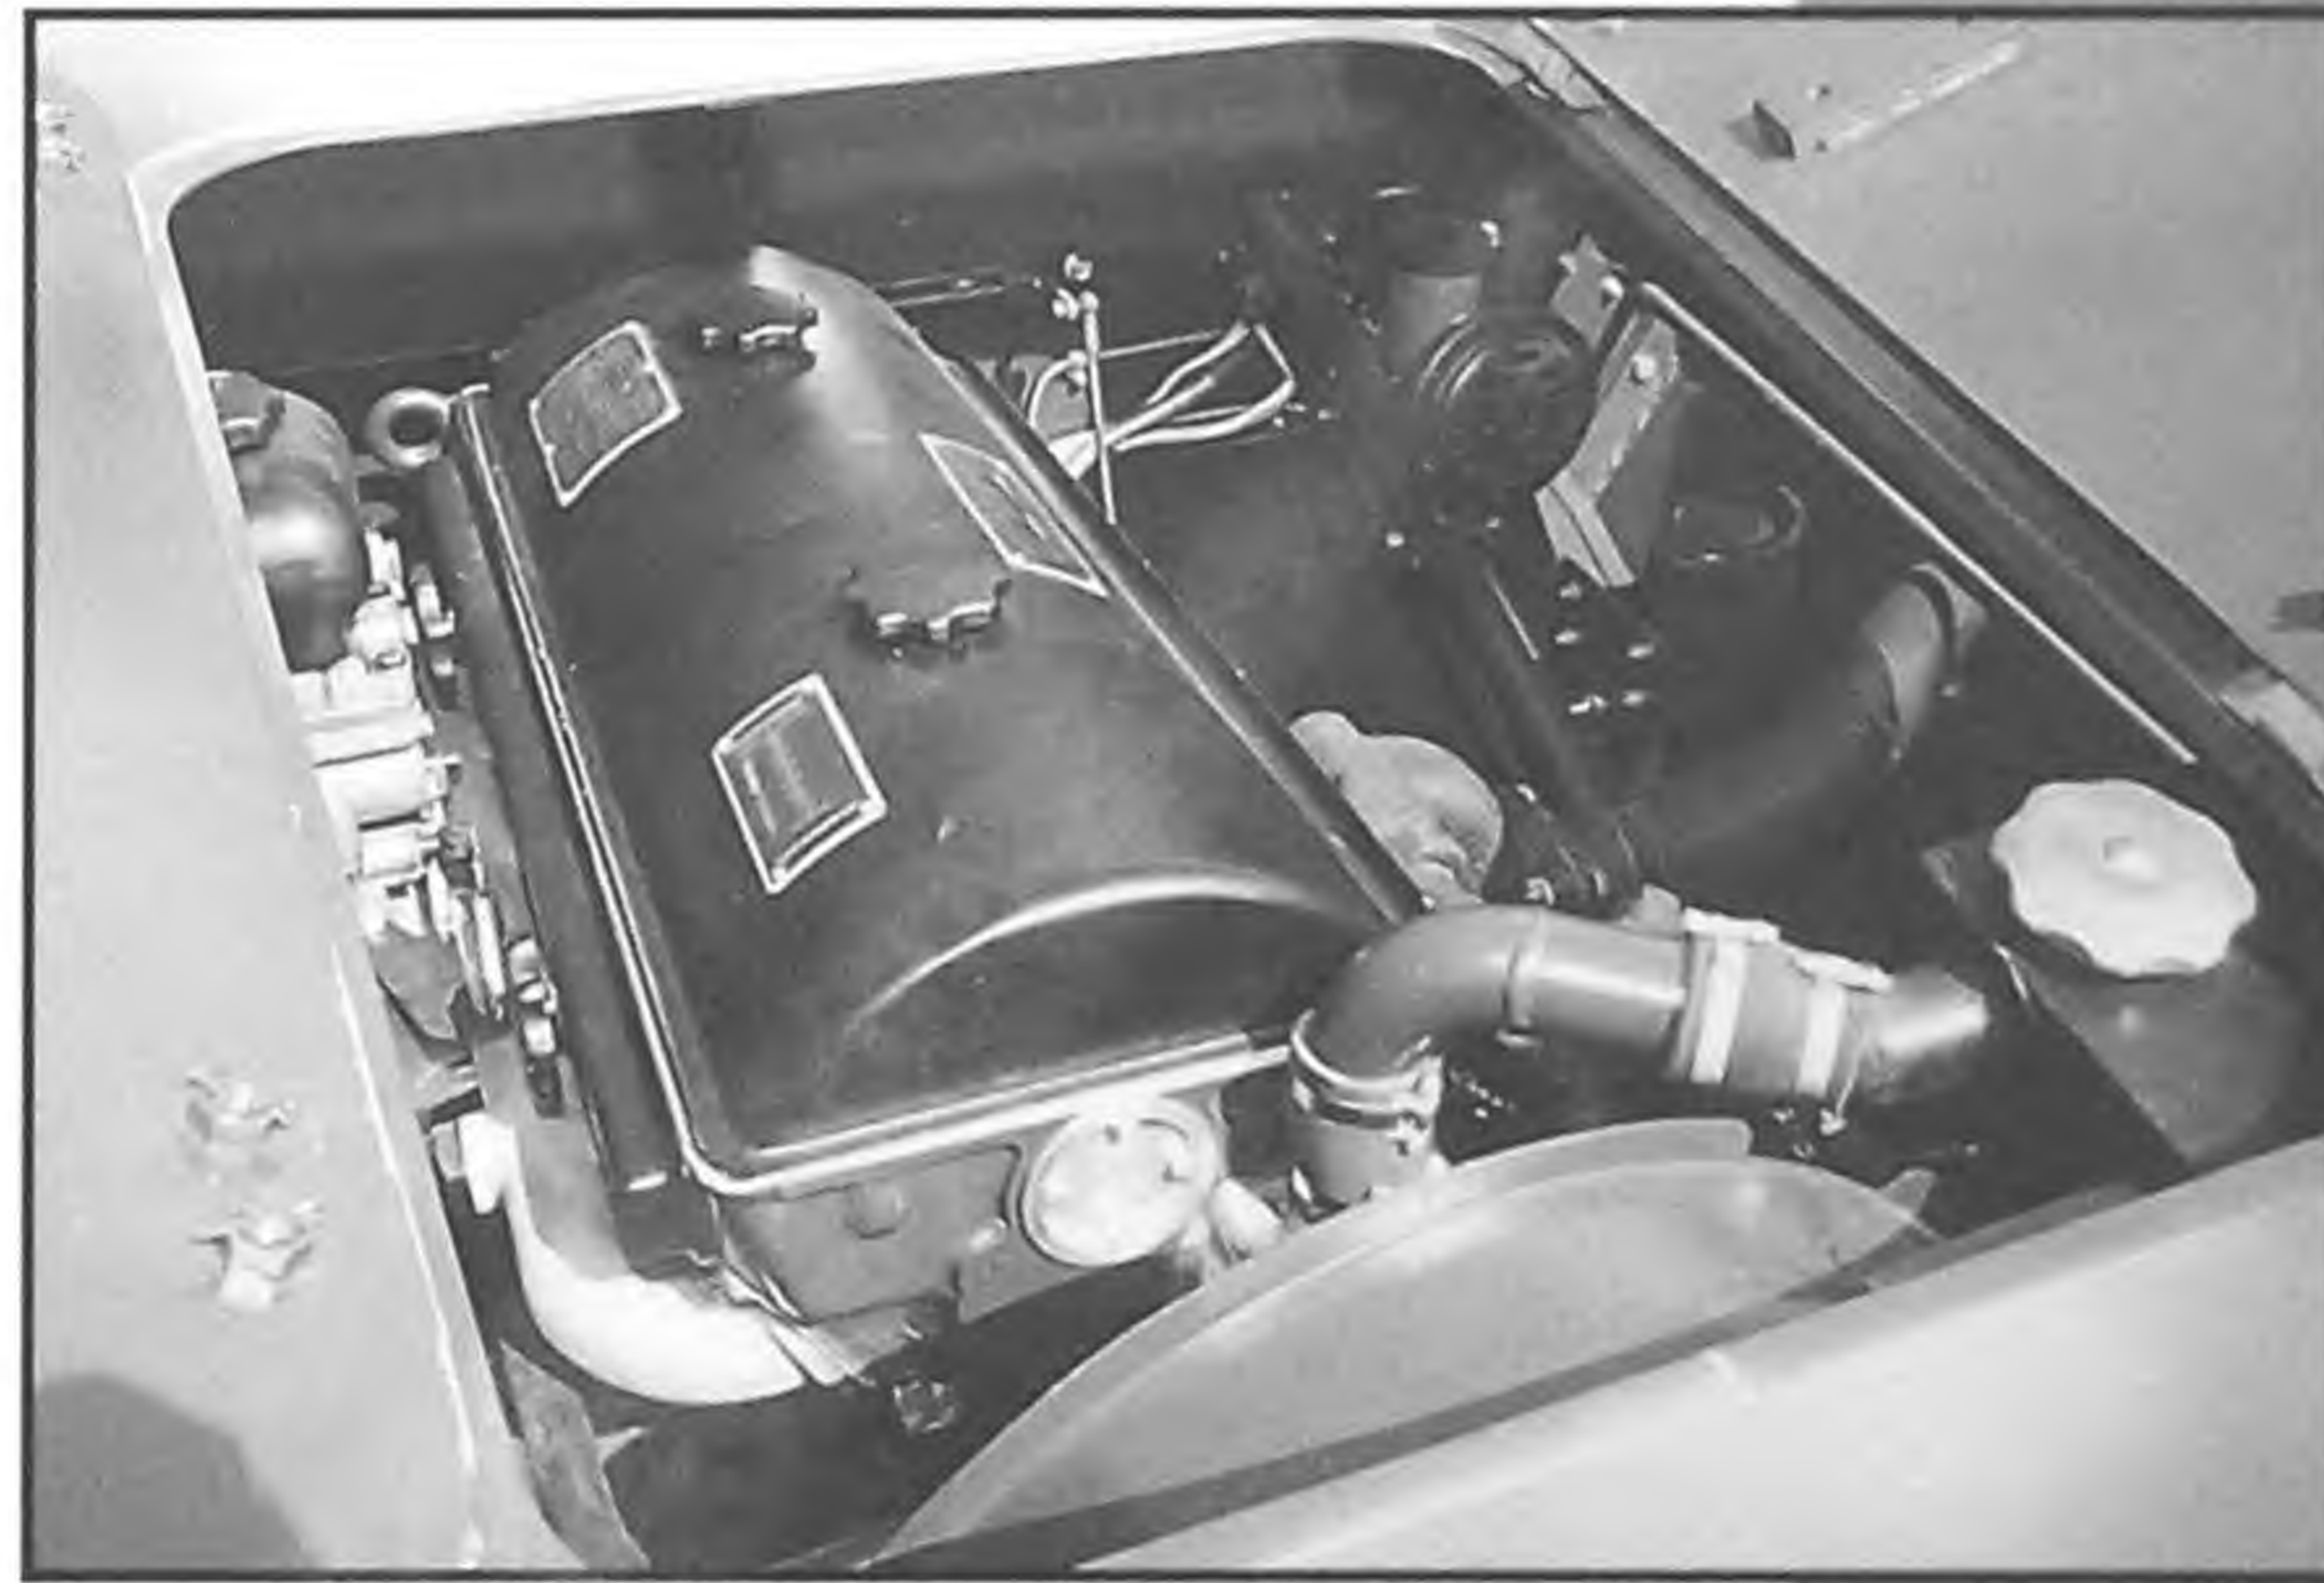
**Top left:** The left rear fender area showing the rear Notek light. **Top right:** The right rear fender. The right side contained a simple distance marker light. Note the data plate on the back of the right side stowage box. **Above left and right:** Overall views of the Maybach HL42TRKM engine as seen through the open

front access hatches. In the left hand shot the Solex two-barreled carburetor can be seen and in the right hand shot the radiator hose and housing is visible, as are the vehicle horn and the top of the exhaust manifold.

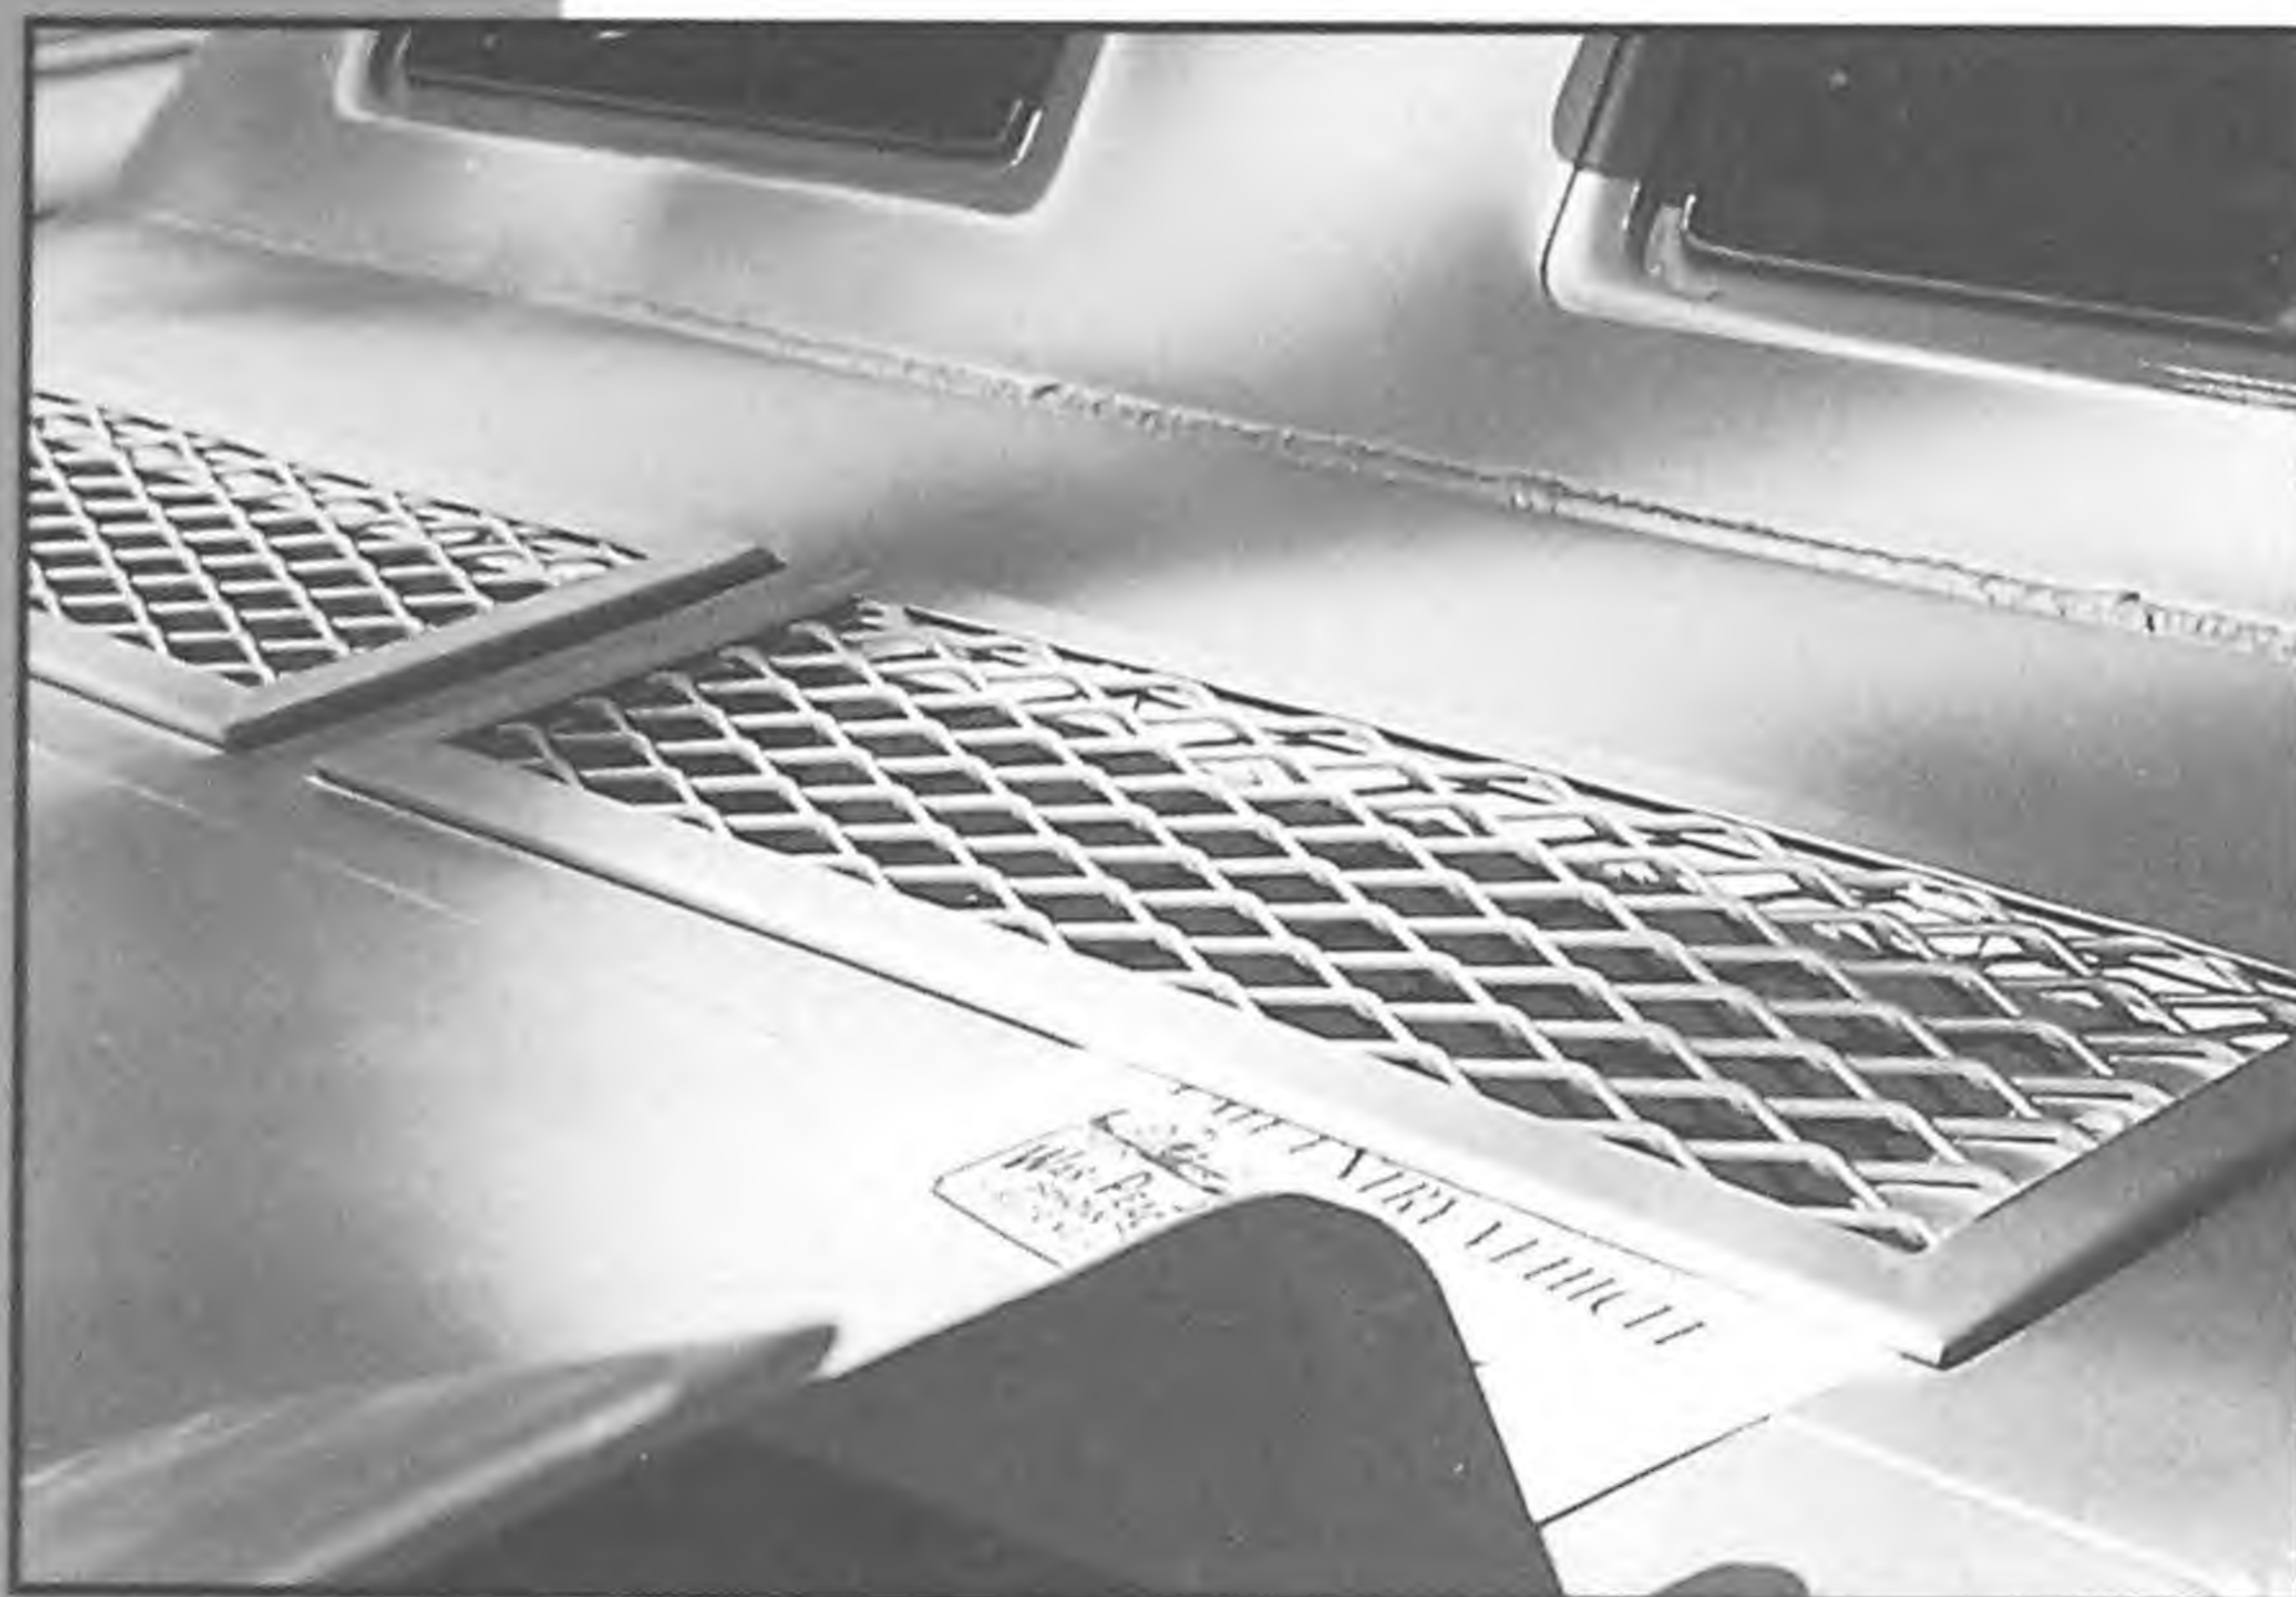
**Top left:** The engine access hatch on the right side of the engine compartment. This shot provides a closer look at the Solex carburetor and the intake manifold. The top of the right side stowage box and the rear of the pick can also be seen. **Above left:** These two grated openings provide ventilation for the engine and are located just in front of the driver's visor. **Above right:** A close-up of the latching mechanism on the side engine access hatch.

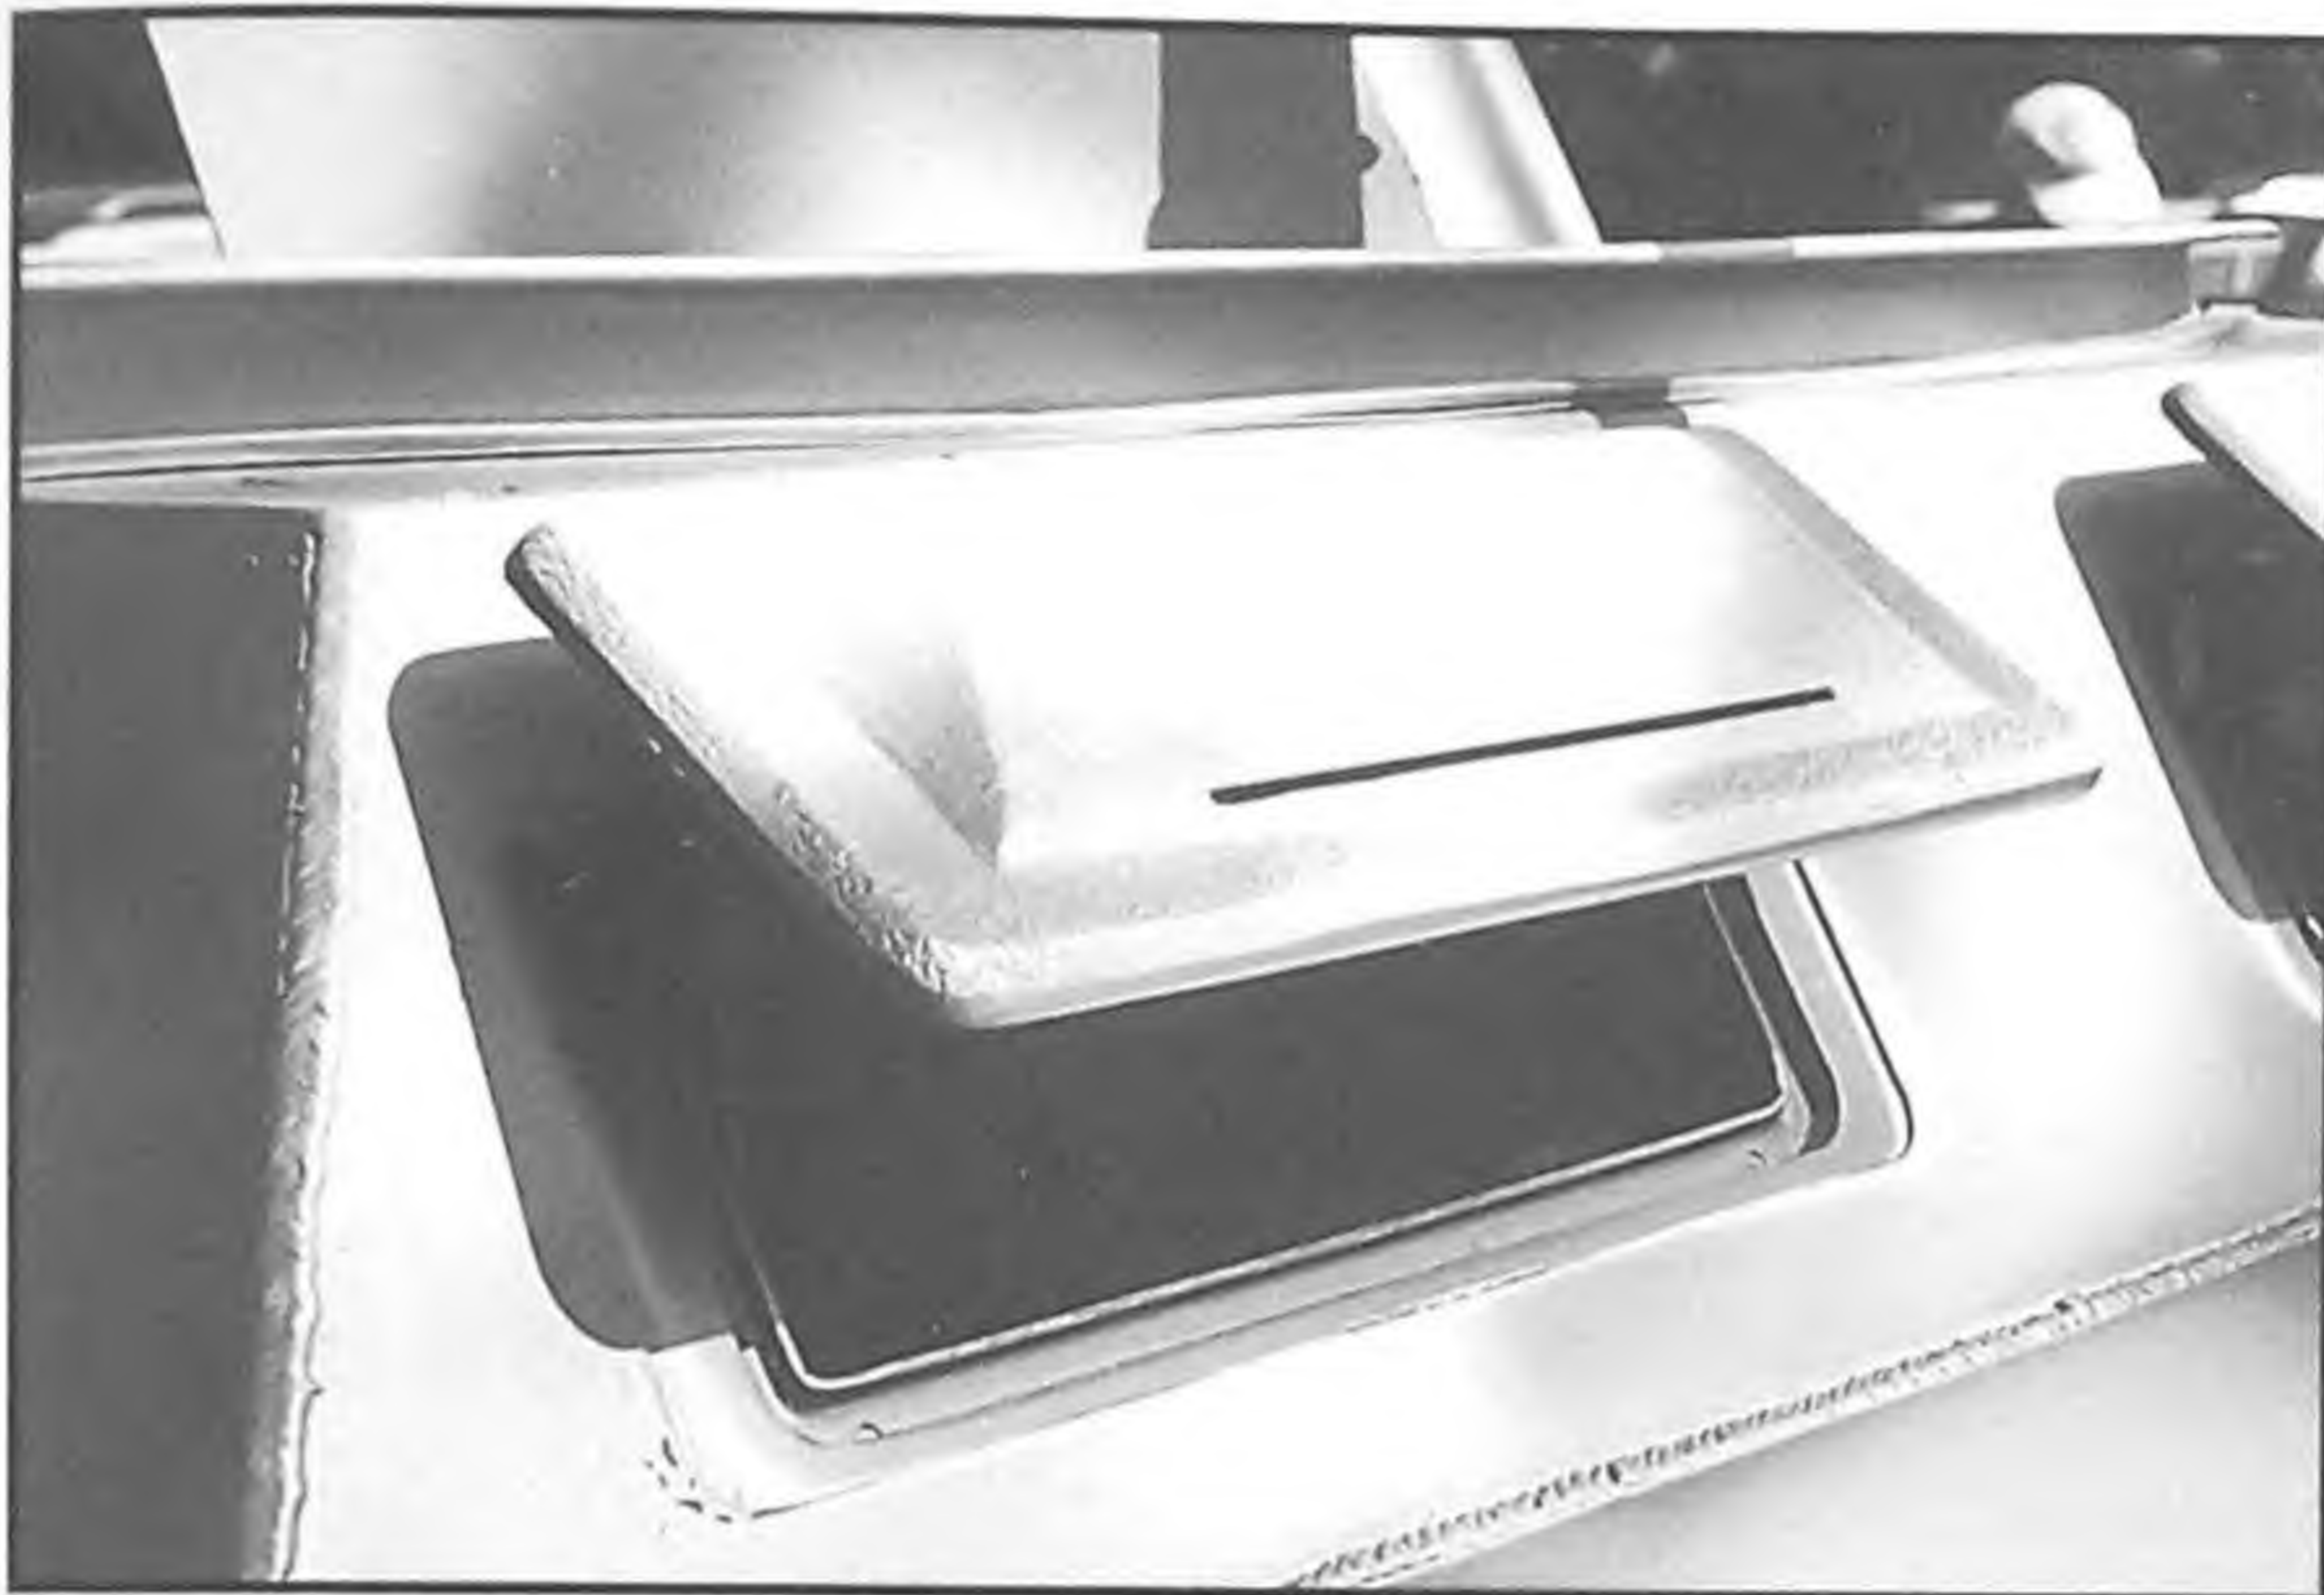
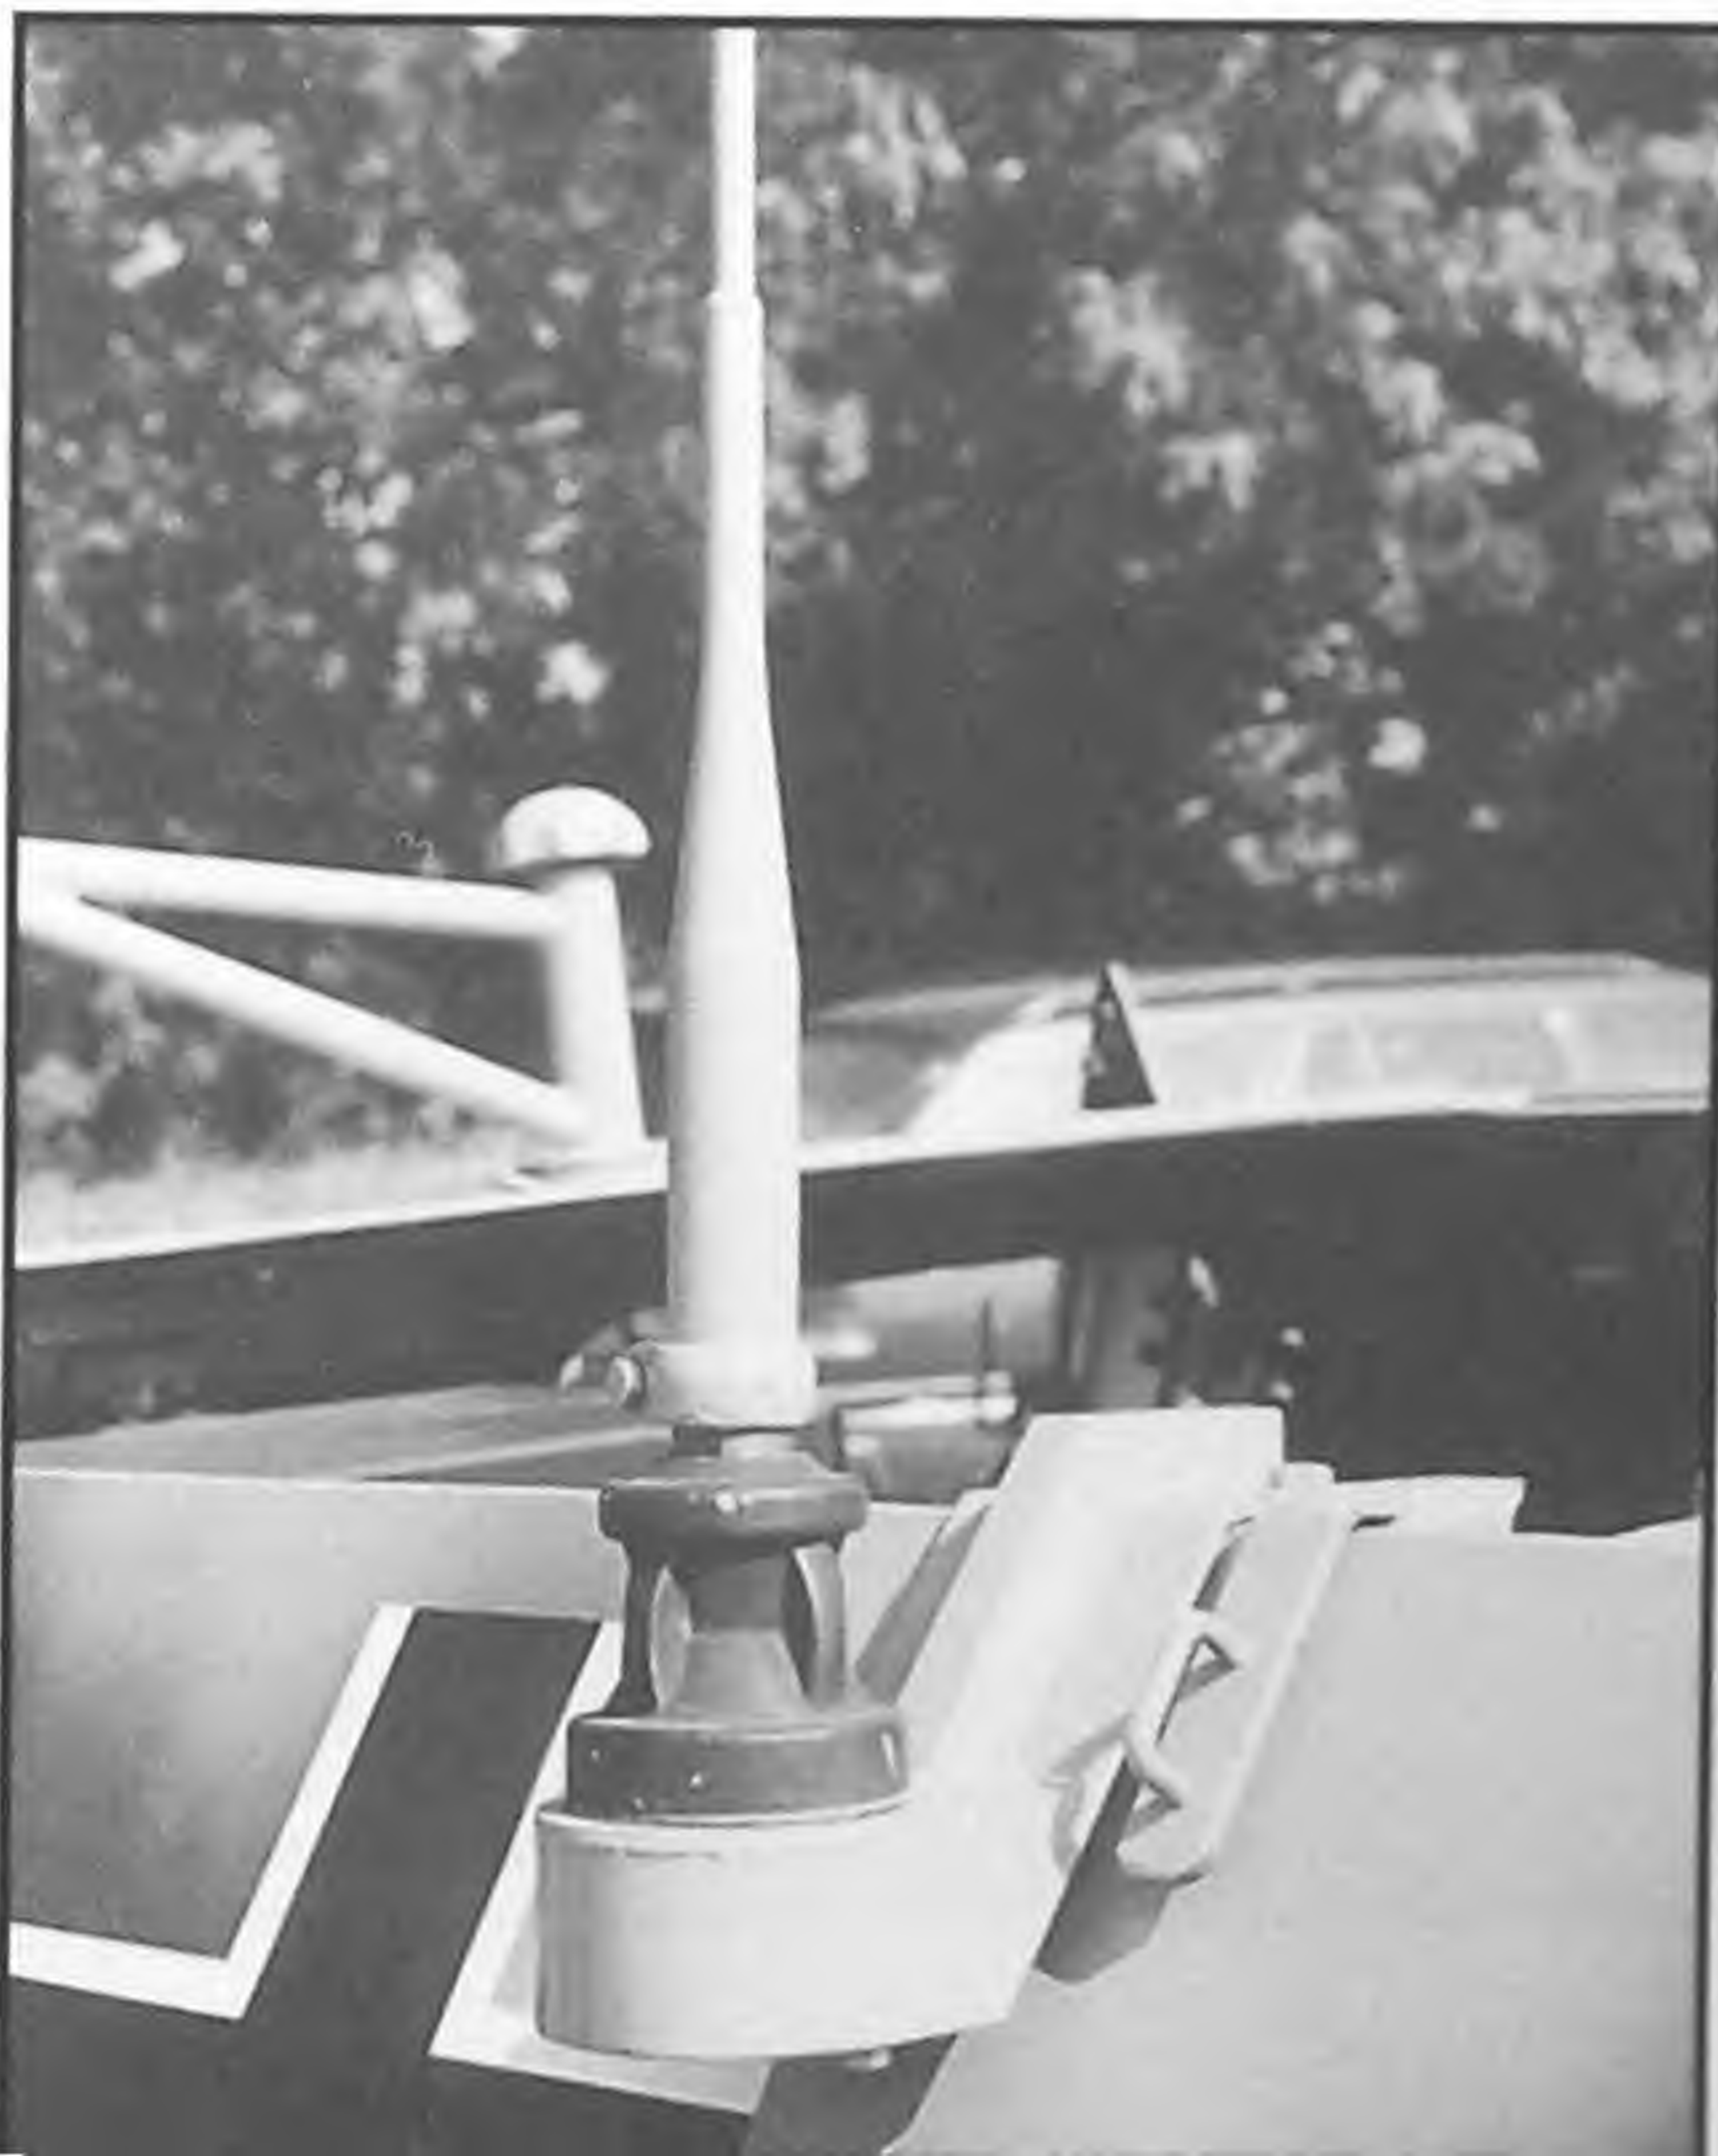
**Top left:** This is the radio operator's visor. It is a cast, armored piece and the opening is also fitted with armored glass.  
**Top right:** The right side driver's visor. Note that the two side visors contain conical head bolts. **Above left:** one of several tie-down points located on the periphery of the hull. **Above right:** The antenna mount for the on-board FuG Spr 1 radio set. The base of the antenna is wider than the type installed on Panzers and the rod itself is a two-part assembly.
